Contract #: 04-0120F4Cty: SF/ALA Rte: 80 PM: 13.9/14.3,0.0/1.6File #: 69.28**WELDING INSPECTION REPORT****Resident Engineer:**Pursell, Gary**Address:** 333 Burma Road**City:** Oakland, CA 94607**Report No:** WIR-000817**Date Inspected:** 09-Nov-2007**Project Name:** SAS Superstructure**OSM Arrival Time:** 2300**Prime Contractor:** American Bridge/Fluor Enterprises, a JV**OSM Departure Time:** 730**Contractor:** Zhenhua Port Machinery Company, Ltd (ZPMC), Changxing Island **Location:** Shanghai, China

Bridge No: 34-0006**Component:** Caltrans Mockup**Summary of Items Observed:**

Caltrans Quality Assurance (QA) Inspector, Mike Hasler was present to observe the fitup, welding and related activities associated with the fabricating of Caltrans Mock-up, 77M, 89M, 114M and U-Rib Trial Assembly, for the San Francisco Oakland Bay Self Anchored Suspension Bridge, at Zhenhua Port Machinery Company (ZPMC) facility on Changxing Island.

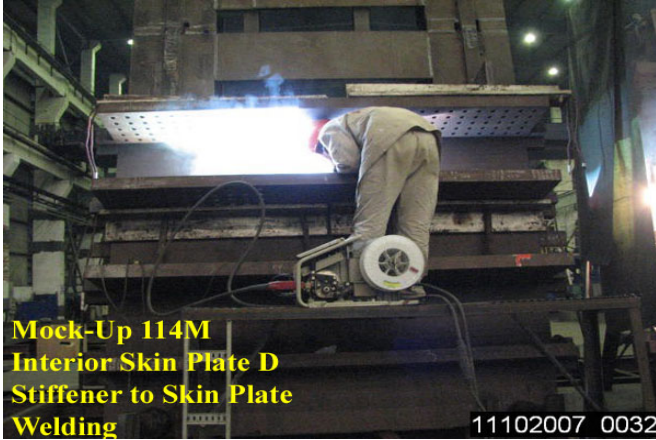
Mock-Up 114M, Interior Skin Plate D: Caltrans QA Inspector observed flux cored arc welding (FCAW), complete joint penetration (CJP) longitudinal stiffener (p920-2) joining skin plate A75 in the flat position. The welder is identified as Mr. Chang Chuancang, welder stamp 053870. The welder is using welding procedure specification WPS-B-T-2231-TC-U5-F, Revision 1. Caltrans QA observed ZPMC Quality Control inspector, Mr. Xu Lefeng and Bureau Veritas (BV) inspector, Mr. Hou Jing Yao, monitoring welding activities at the workstation. Caltrans QA Inspector measured current welding parameters at approximately 310 amps, 31.5 volts and 250 millimeters per minute (mm/min) travel speed. Preheat and interpass temperatures were verified during welding activities. The preheat temperature prior to the start of welding measures more than 110 Celsius (230 degree Fahrenheit) but less than 232 Celsius (450 degrees Fahrenheit) during maximum interpass temperature verification. FCAW welding consumable is verified and identified as Supercored 71H, classification E71T-1, diameter 1.4 mm (.055 inches). Following digital picture illustrates welding in progress.
